## Appendix B

### Ice Jam Mitigation Case Studies

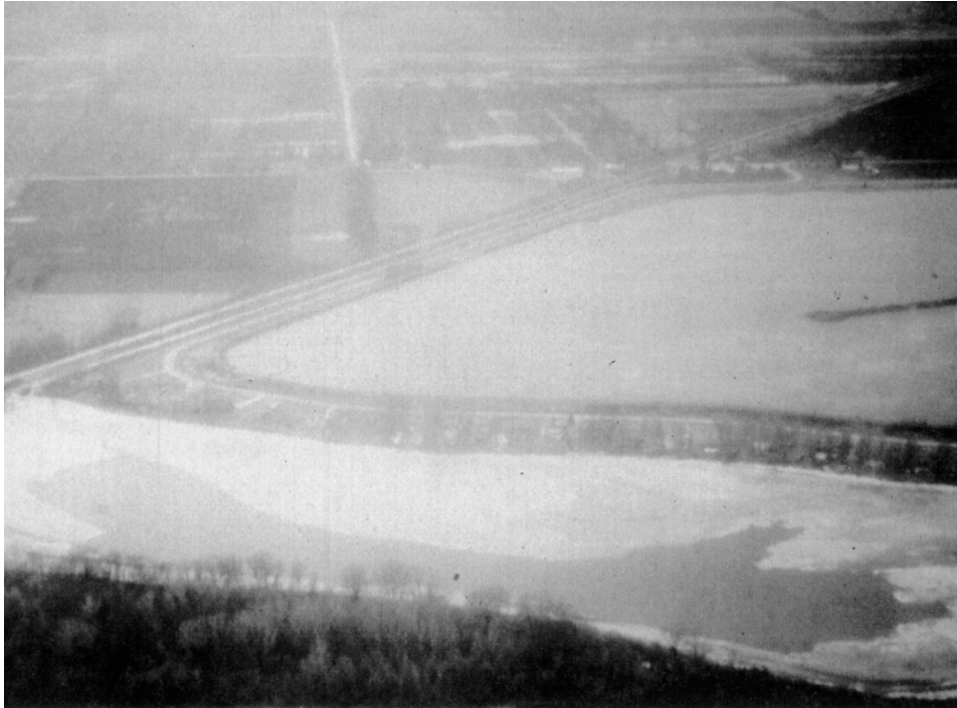
Figure B-2. Map of meltout, Kankakee River, Illinois

*b.* In a demonstration project, 20°C (68°F) water from the cooling ponds adjacent to the Kankakee River near Wilmington was siphoned in three 0.76-m-diameter (30-inch-diameter) pipes into the river upstream of the ice cover for 2 weeks prior to the anticipated breakup in 1988 (Figure B-1). The maximum siphon flow is 4.25 m<sup>3</sup>/s (150 ft<sup>3</sup>/s) compared with the expected river flow of approximately 113 m<sup>3</sup>/s (4000 ft<sup>3</sup>/s). The measured rise in water temperature was less than 0.56°C (1°F). The warm water input melted the existing ice so that ice floes passed unhindered during the natural breakup period and flooding was averted (Figure B-2).

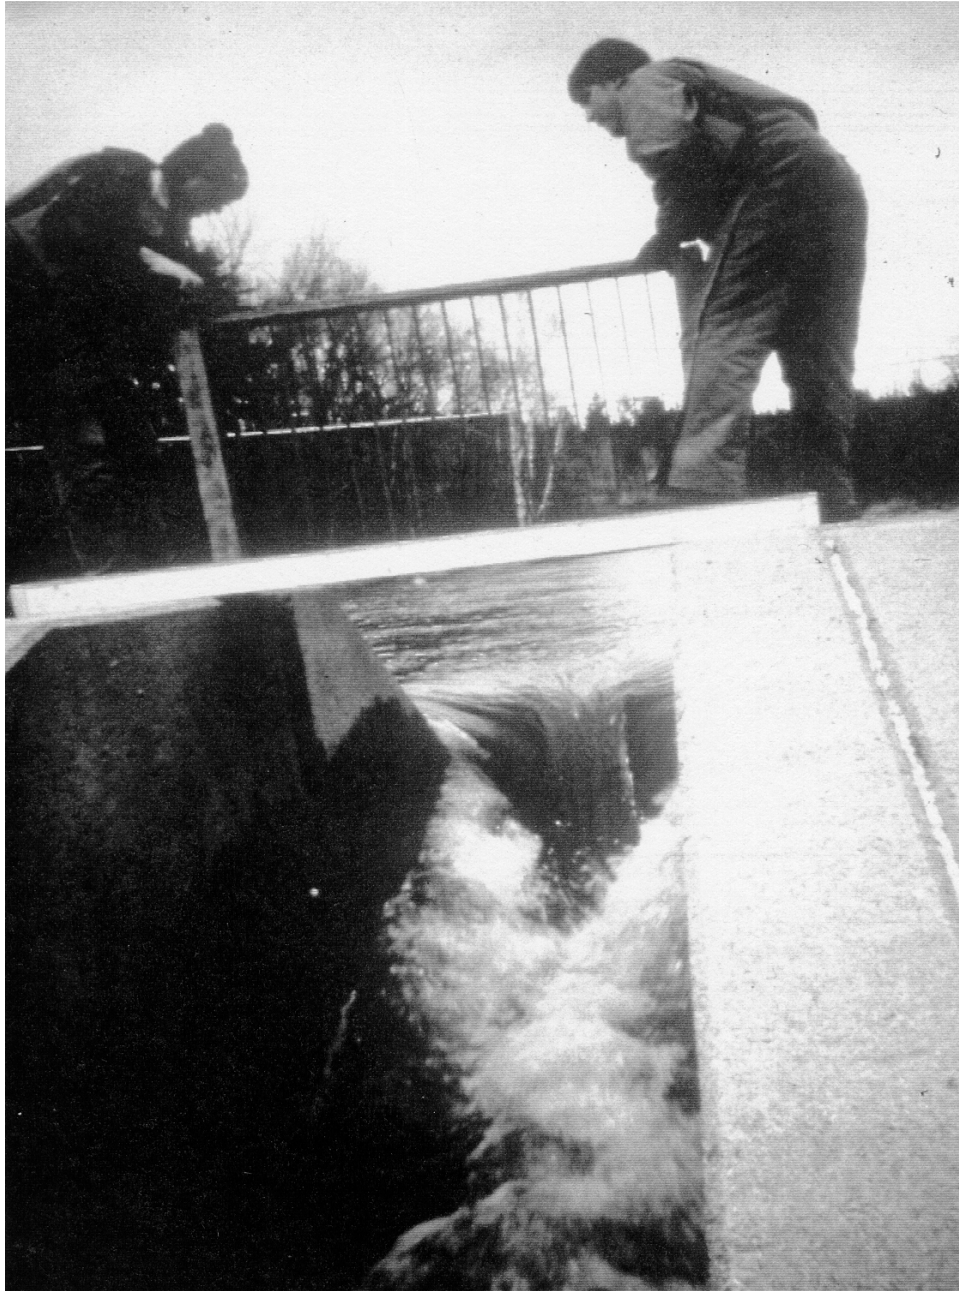
a. Installing racks in sluiceways

Figure B-5. Lancaster, New Hampshire, weir

*c.* The ice control weir includes four 1.2-meter-wide by 2.4-meter-deep (4-foot-wide by 8-foot-deep) sluiceways for fish passage. During the winter, stop logs or metal bar racks are placed in the sluiceways to develop an ice retention pool. The pool forms an ice cover, and frazil ice generated upstream deposits beneath the ice cover. After the ice cover has formed, two of the gates are opened, allowing the pool level to drop. This creates additional water storage in the pool area, provides additional discharge capacity through the weir, and slightly delays the breakup and movement of ice through the pool as well. The project, which cost \$300,000 was completed in 1982. Although costs constrained the size of the project to less than ideal, no major flooding has occurred since this relatively inexpensive, innovative project was constructed (Axelson 1991).

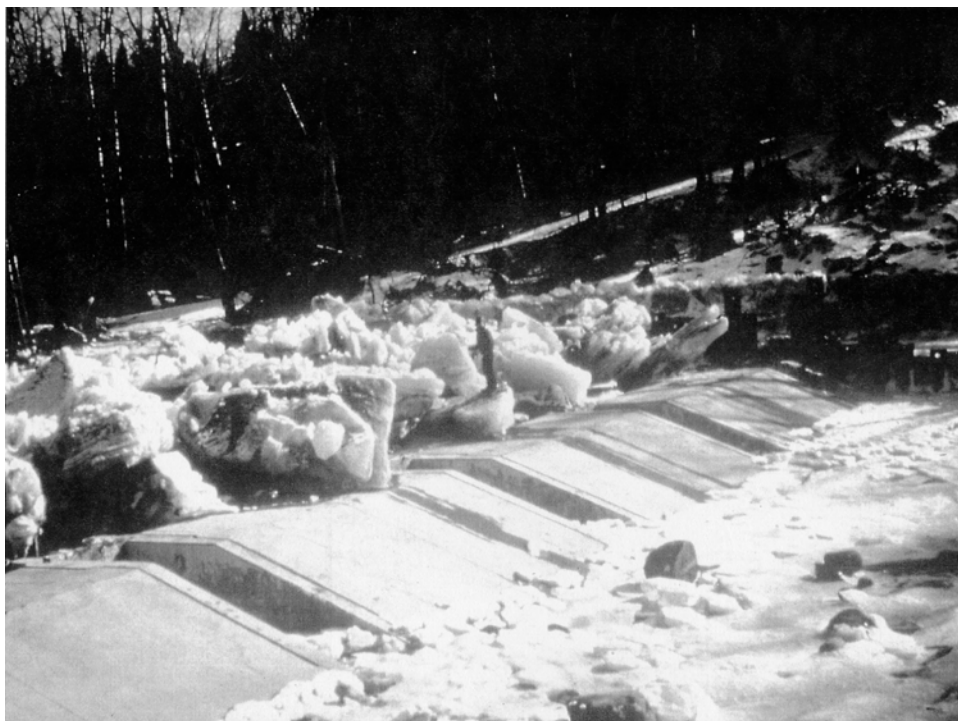
**b. Ice accumulated behind structure in early spring**

**Figure B-5. (Concluded)**

*b.* The Corps' New England Division (now New England District) and CRREL designed and built an ice control project to reduce the production and transport of frazil ice and decrease the volume of ice available to ice jams downstream. Environmental and financial constraints limited the scope of the project, which ideally would have provided the same protection as the four dams. The project consists of two parts: 1) a submarine net to capture surface ice, and 2) a 36.6-meter-long by 2.7-meter-high (120-foot-long) by 9-foot-high permanent weir located several miles downstream (Figure B-5). The submarine net is a form of suspended ice retention structure that allows water to flow through but captures floating ice pieces, which are then stored in overbank floodplains.
